Salt River Watershed, **Rio Salado Oeste**, Phoenix, Arizona

Rio Salado, Rio Salado Oeste Phoenix, Arizona Ecosystem Restoration Project

**H&H for Planners
February 2011**

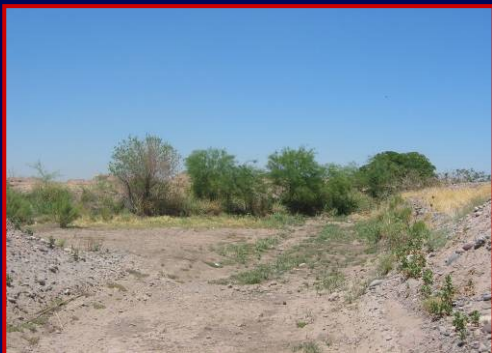
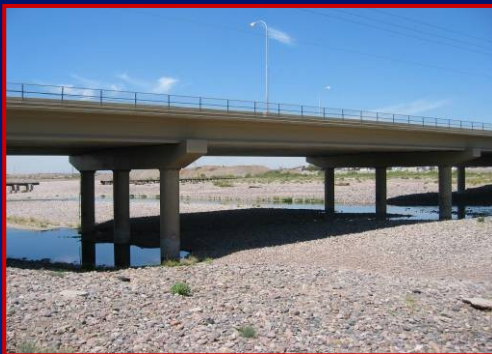
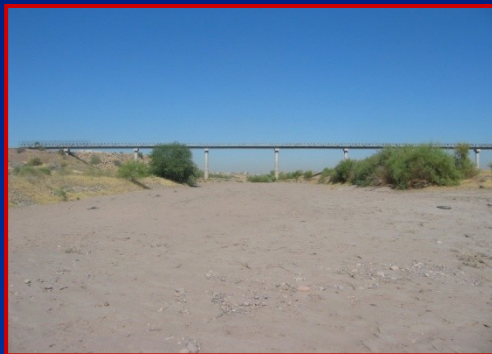
Before

Recommended Plan - Alt 5A

Water supply

River channel restored

Revegetation

**Invasive species
removed**

Gravel pits restored

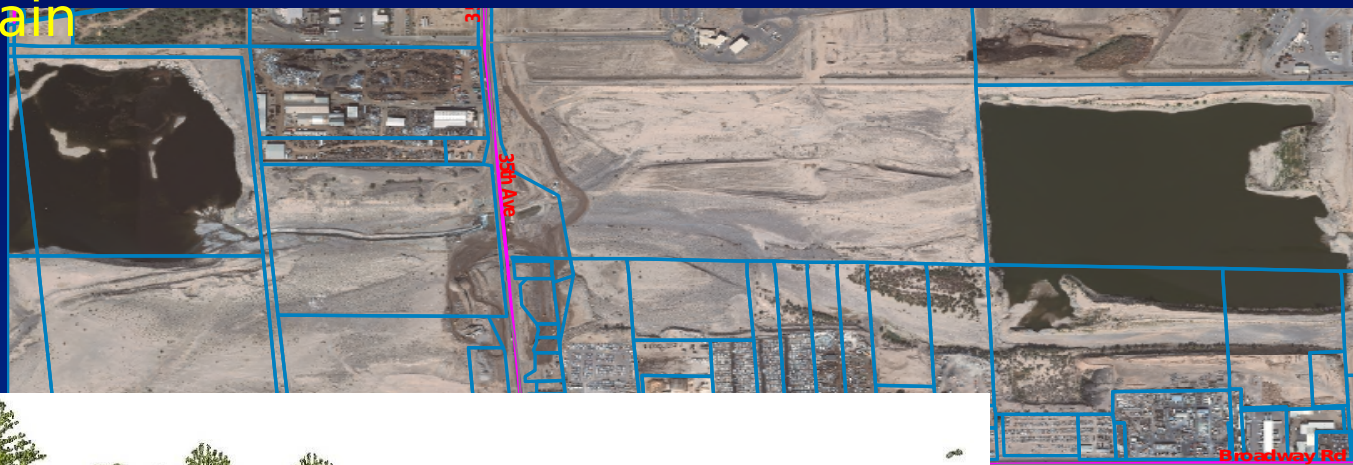
27th and 37th Avenues

Reshaping/cut and fill

~3M cy

Tie into
channel/floodplain

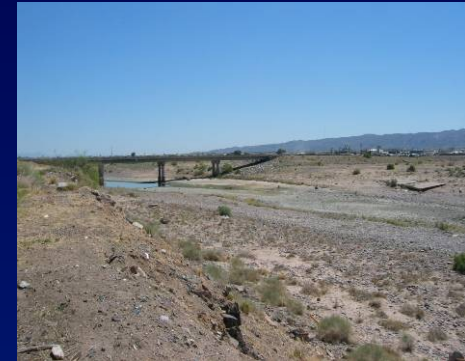
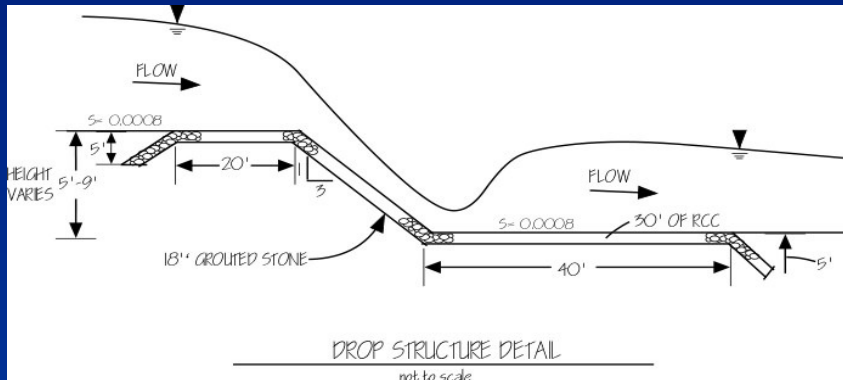
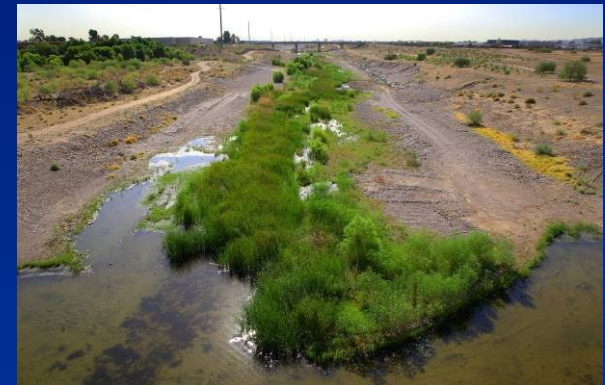
Channel Restoration

Restored river channel *similar* to historical channel

Grading/Terracing within 10 yr
20,200 cfs design discharge
Cut/Fill 660,000 cubic yards
Grade Control at 35th Avenue
Bridge
